Manhole Inspection Summary

Manhole # S27M__044MH

Insp Date: **5/5/08 2:09 PM**

Location Address: **1214 W. Ostend**

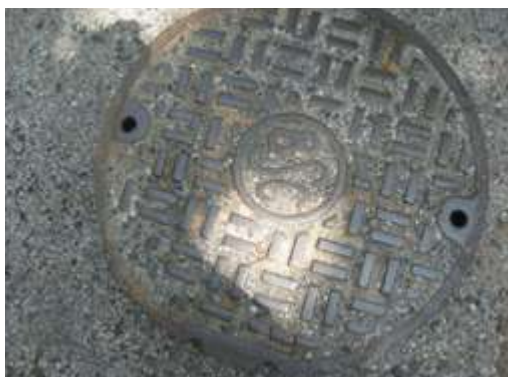
Cover View

Type: **Sanitary** Condition: **Sound** Cover Material: **Cast Iron**

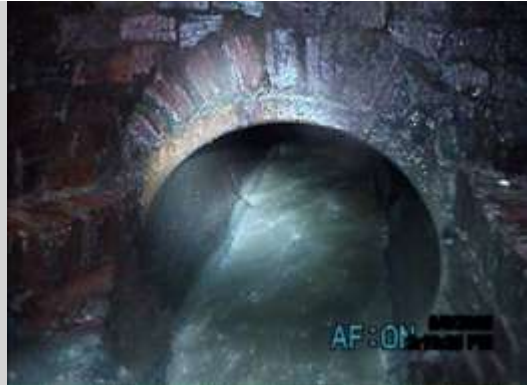
12 O'Clock Outflow

24 in. Circular Gravity Sewer
Pipe Out @ 12 O'Clock

Pipe Height: **22.8** (in.) Rod and Bar (Angled)
Pipe Material: **Clay** ☐ Pipe Lined
Invert Depth: **14.30** (ft.) Flow Characteristics: **Fast**
Deposits: ☒ None ☐ Mud ☐ Sludge ☐ Debris ☐ Grease
Silt Depth: **0** (in.) Deposits Extent:
Infiltration: **None** Pipe Seal Cond: **Sound**

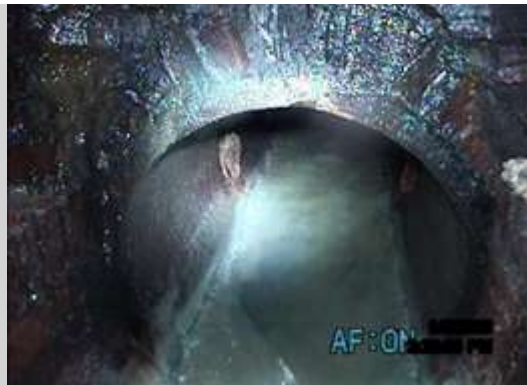
6 O'Clock Inflow

24 in. Circular Gravity Sewer
Pipe In @ 6 O'Clock

Pipe Height: **22.8** (in.) Rod and Bar (Angled)
Pipe Material: **Clay** ☐ Pipe Lined
Invert Depth: **14.25** (ft.) Flow Characteristics: **Fast**
Deposits: ☒ None ☐ Mud ☐ Sludge ☐ Debris ☐ Grease
Silt Depth: **0** (in.) Deposits Extent:
Infiltration: **None** Pipe Seal Cond: **Sound**

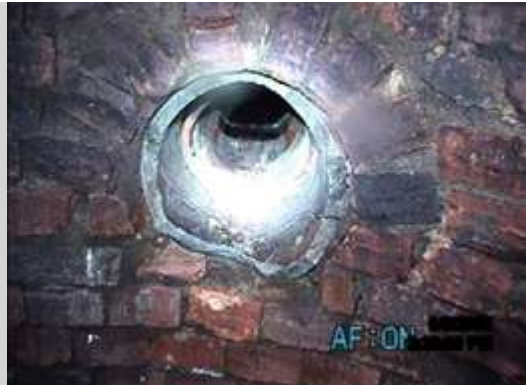
9 O'Clock Inflow

8 in. Circular Gravity Sewer

Drop In @ 9 O'Clock

Pipe Height: **8.4** (in.) Rod and Bar (Angled)

Drop Condition: **Partly Clogged**
